# Manhole Inspection Summary

Manhole # S15C1\_018MH

Insp Date: **5/28/08 12:34 PM**

**Location** Address: **1801 inverness av**

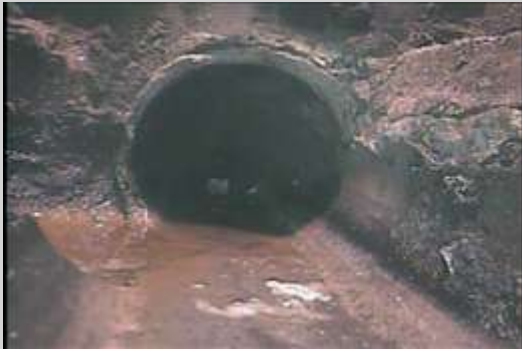
12 O'Clock Outflow

Pipe Height: **8.4** (in.) Rod and Bar (Angled)  
Pipe Material: **Clay** ☐ Pipe Lined  
Invert Depth: **12.32** (ft.) Flow Characteristics: **Slow**  
Deposits: ☒ None ☐ Mud ☐ Sludge ☐ **Debris** ☐ Grease  
Silt Depth: **0** (in.) Deposits Extent:  
Infiltration: **None** Pipe Seal Cond: **Sound**

Drop: **None**
